# AERIAL PHOTOGRAPH OF MASTER METALS, Cleveland, Ohio

TS-PIC-93069/94069  
January 1994

AERIAL PHOTOGRAPHIC ANALYSIS OF MASTER METALS, INC.

Cleveland, Ohio

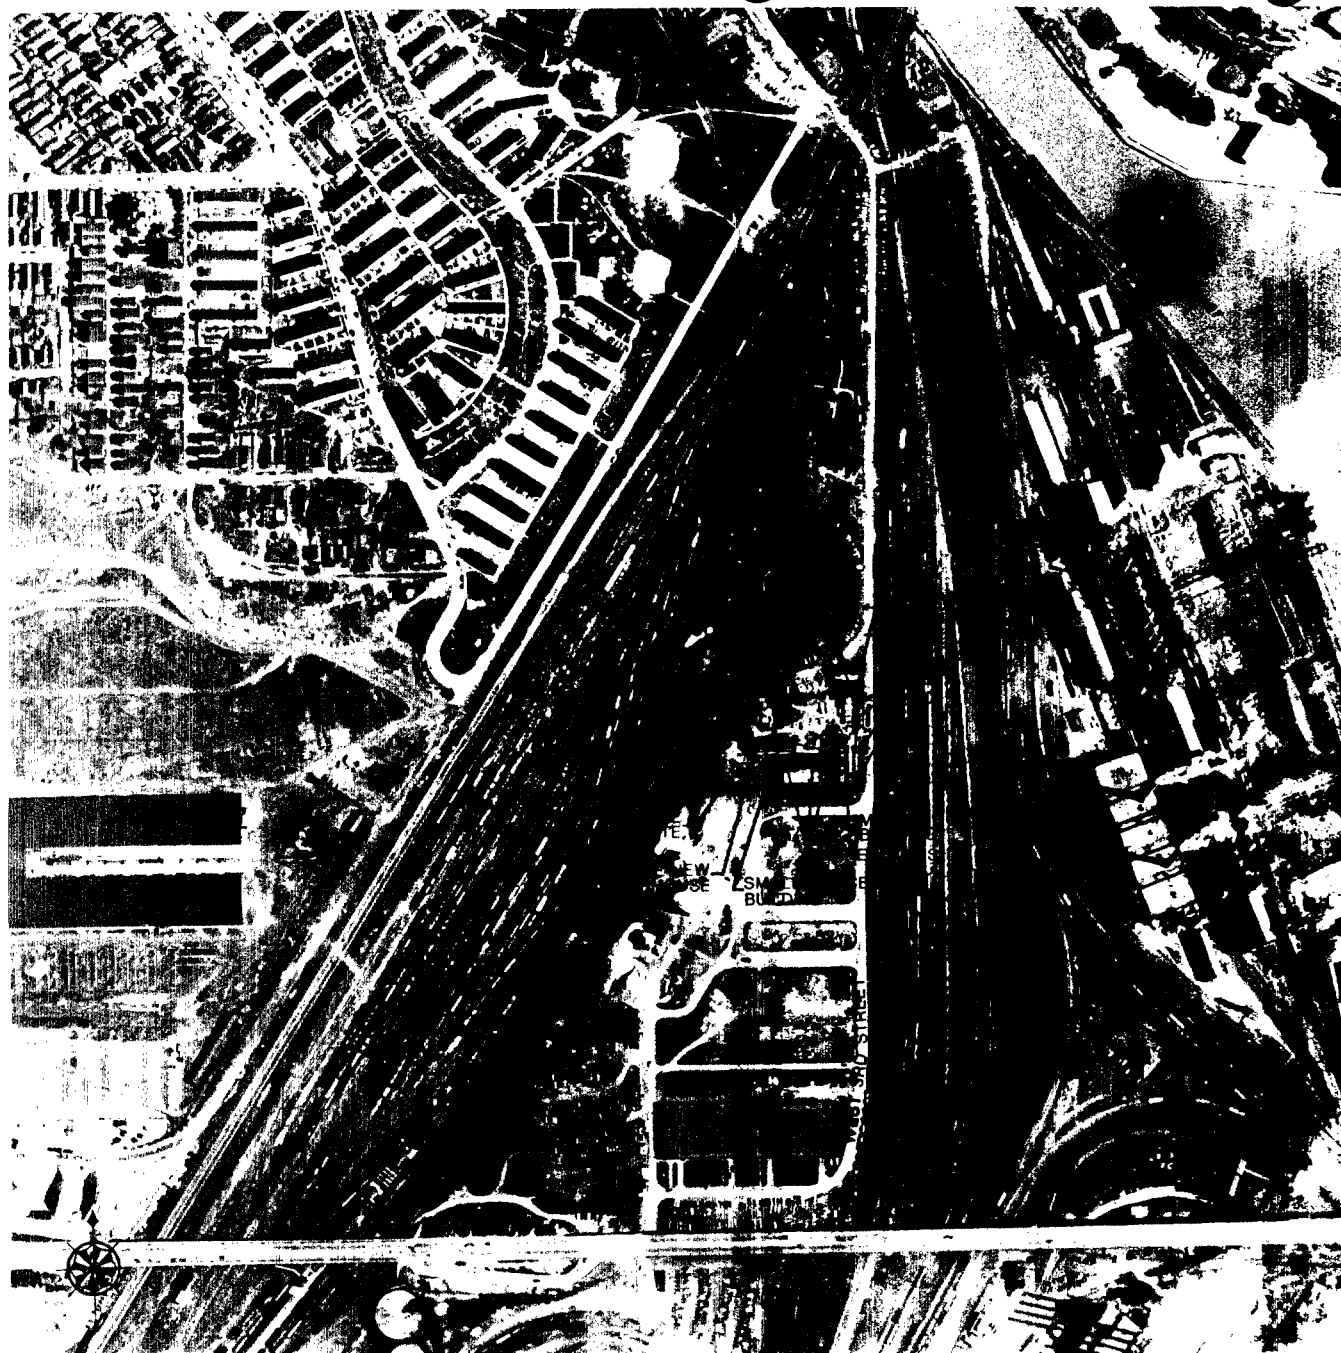
Figure 4. Master Metals, Inc., Ohio, May 9, 1951. Approximate scale 1:4,433.

MAY 9, 1951 (FIGURE 4)

By 1951, Master Metals, Inc., had expanded its site west to the B&O marshalling yard, increasing the occupied land to approximately 1.9 acres. A perimeter wall had been erected along the B&O marshalling yard. Additions had been made to the office building and conveyors had been added to the three small warehouses, connecting them to the main processing building. A probable, new powerhouse had been added to the small processing building. Almost all the space added to the site was bare ground containing three piles of solid material. The material was in a front-loader/dump truck configuration, indicating probable waste rather than raw materials. There were, also, two small piles of probable solid waste next to the vehicle access point in the northeast corner of the site. There were four box cars on the rail spur along the east side of the main processing building. Steam was rising from both processing buildings. A new street (West 3rd Street) had been built along the east perimeter of the site. The remainder of the plant appeared unchanged.

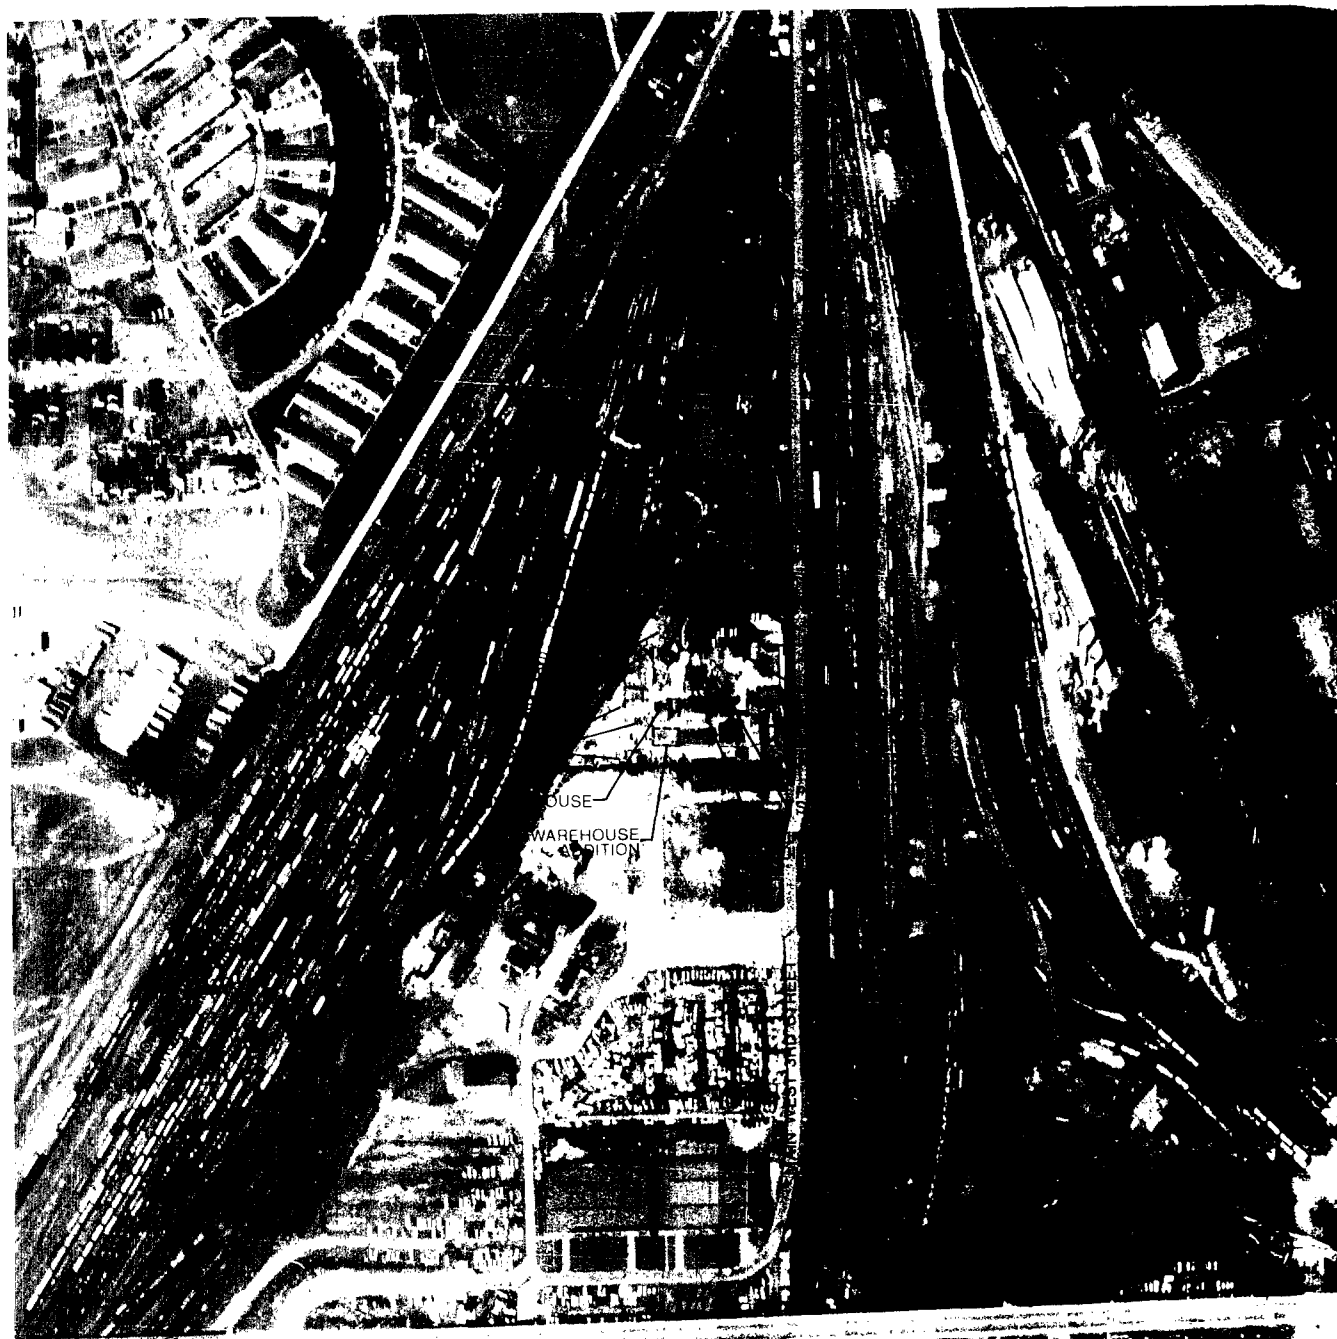
Figure 5. Master Metals, Inc., Ohio, April 8, 1962. Approximate scale 1:3,547.

APRIL 8, 1962 (FIGURE 5)

An addition had been made to the west end of one of the existing warehouses. Waste material was still being stored in the triangular area at the southwest end of the site; however, this waste now appeared to be more in the form of scrap than dry material. A small pile of probable solid waste was located between the office building and the small support building. The small pile of solid waste previously located near the main vehicle access had been removed. The site now lacked a northern perimeter fence; however, a low wall had been constructed, blocking the old vehicle access point. The remainder of the site appeared unchanged.

The 1962 photography revealed the following changes to the site. The north perimeter fence from the B&O marshalling yard to the office building had been removed. The perimeter wall had been extended, along the B&O marshalling yard, north to the turntable associated with the rail roundhouse. A new processing building had been constructed along this wall, which appeared to have an accompanying, medium-sized, smokestack. Several tractor-trailers were also parked along this new wall.

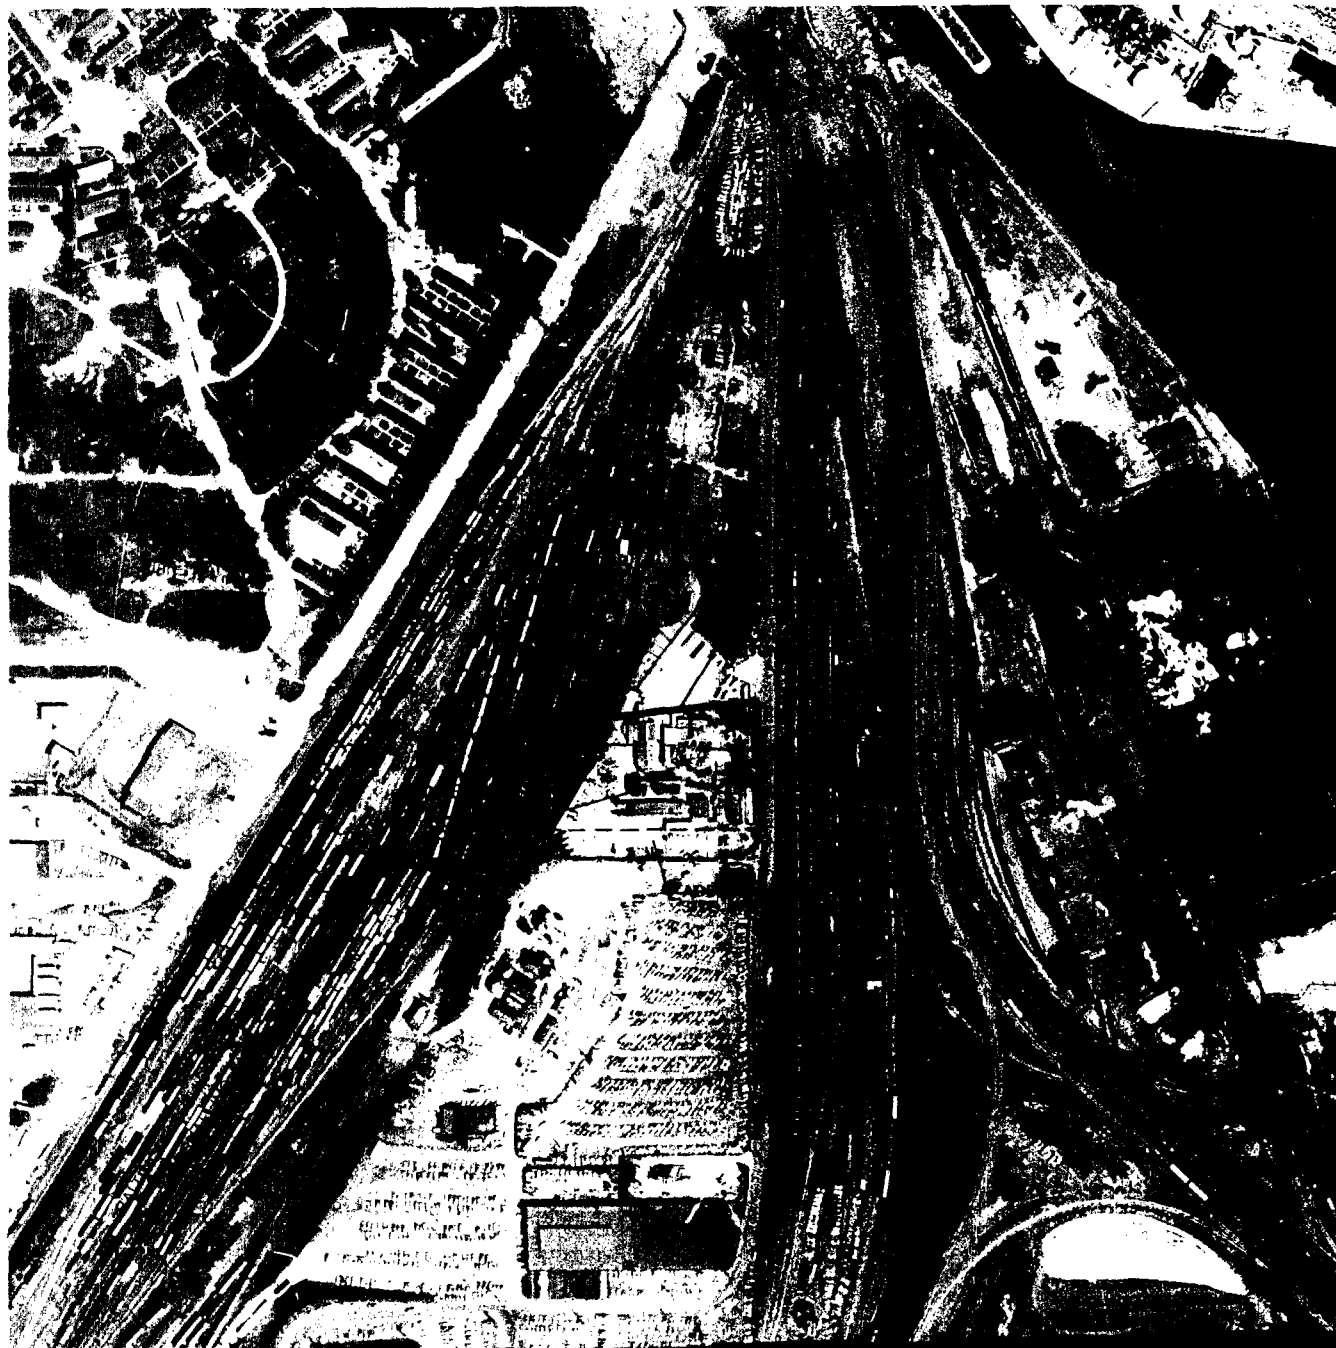
Figure 6. Master Metals, Inc., Ohio, May 11, 1977. Approximate scale 1:3,775.

MAY 11, 1977 (FIGURE 6)

A perimeter configuration change had taken place at the site by 1977. The "new" wall and "new" processing building (Figure 5) added to the site prior to 1962, had both been removed. Another new processing building had been built directly north of the powerhouse. Although there was still no perimeter fence along the north side of the site, it appeared that the new processing building was now within the original (Figure 3) confines of the site. The material located along the west wall in this photo was arranged in more orderly fashion (rows) and may have been end products rather than scrap. The perimeter fence along the south side of the site had been extended to the south to include another approximately 0.5 acres of land, raising the amount of land occupied to approximately 2.4 acres. A new vehicle access gate has been created in this perimeter, entering the site from West 3rd Street. Four dry material bins had been built in the very southwest corner of this new area and the remainder was being used for an employee parking lot. The original vehicle access gate had been restored. The small amount of probable solid waste located just south of the office building remains. The remainder of the site appeared unchanged.

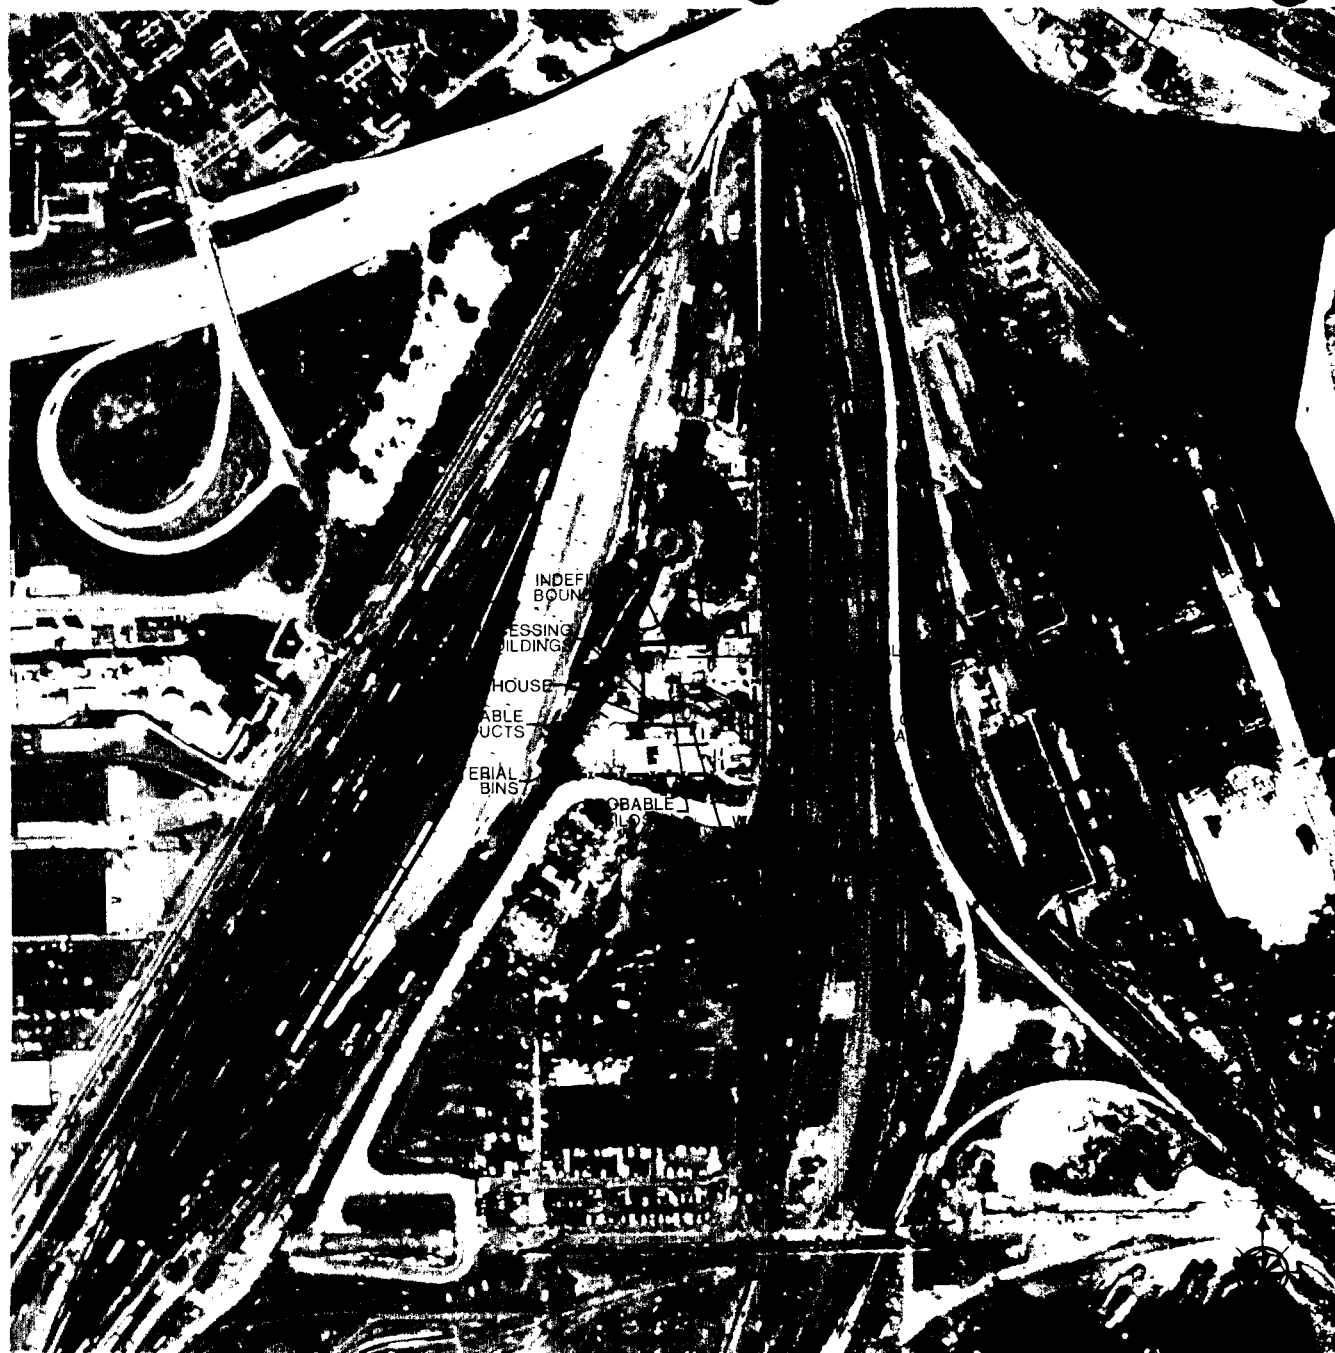
Figure 8. Master Metals, Inc., Ohio, May 15, 1991. Approximate scale 1:4,210.

MAY 15, 1991 (FIGURE 8)

This photo revealed some internal facility changes in the plant area. The small support building, next to the latest constructed processing facility, had been removed, along with the square-type, small warehouse building located just west of the main processing building. In the place of these two buildings, a probable 6-unit silo had been constructed immediately north of the powerhouse and a probable three-unit bank of vertical tanks had been constructed immediately east of the silo complex. These tanks appeared to be connected to the main processing building by a conveyor system. The office building, except for the shed attached to the west end, had been removed. The amount of probable end product inventory stacked along the west perimeter wall appears to have increased in quantity. Dark ground stains were present leading into the northeast vehicle access gate from the roundhouse to the north. The probable solid waste previously located along the south side of the old office building had been removed. There is still no perimeter fence along the north side of the site. The remainder of the site appeared unchanged.
